# **LINNTON OIL FIRE TRAINING GROUNDS CSM Site Summary**

### LINNTON OIL FIRE TRAINING GROUNDS

Oregon DEQ ECSI #1189

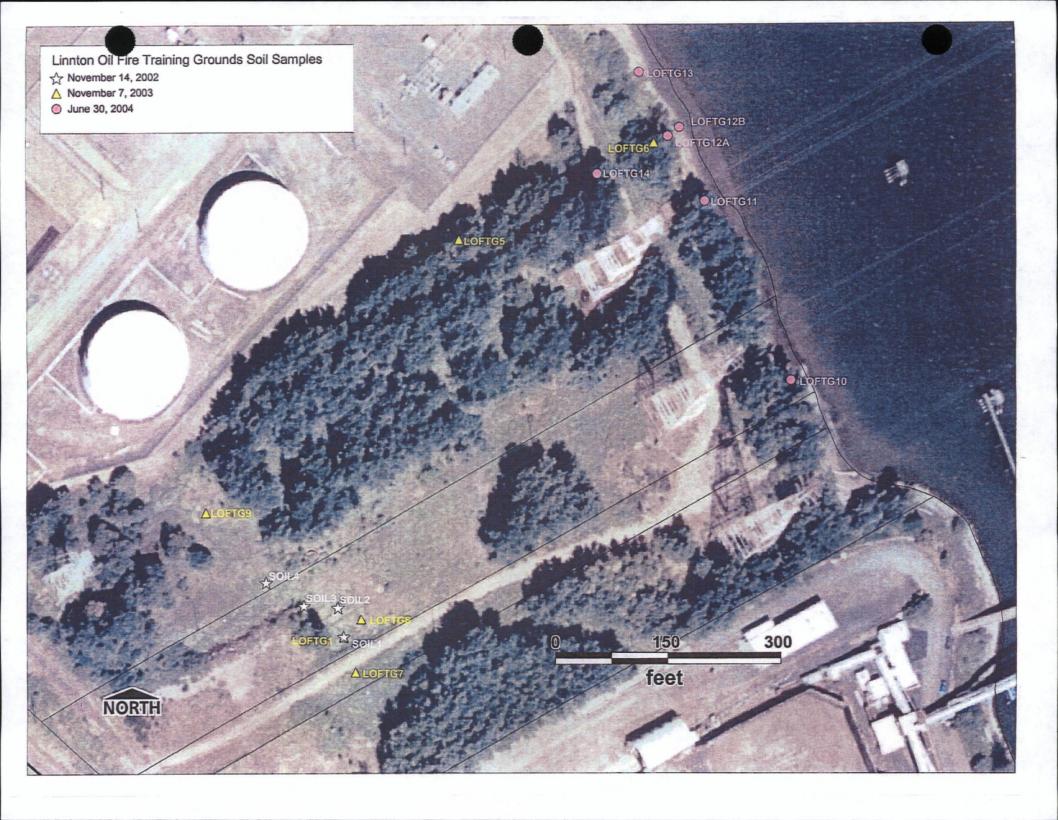
- Figure 2. Monitor Well Locations (CDM 2002)
- Figure 3. Groundwater Elevation Map, October 18, 2001 (CDM 2002)
- Figure 4. Groundwater Elevation Map, April 18, 2002 (CDM 2002)
- Figure Stormwater Pathway Investigation Soil Sample Locations (BES 2004b)

As part of the Surface Water Pathway Evaluation, BES performed three phases of soil sampling (November 2002, November 2003, and June 2004) using a hand auger to assess conditions at depths ranging from 0 to 2.5 feet bgs. A total of 16 soil samples were collected along the drainage system and riverbank and analyzed for PAHs and PCP. The sample locations are shown on Supplemental Figure from BES (2004b). Of the 7 samples with PCP detections, the maximum concentration was 6.87 mg/kg. PCP was detected at a concentration of 1.08 mg/kg in one sample (LOFTG6), collected adjacent to the river embankment culvert. However, subsequent sampling to confirm the presence and assess the extent of PCP in the vicinity of the LOFTG6 indicated no detections of PCP in any of five additional samples. Of the 10 samples with detections of PAHs, the maximum
